UNITED STATES DISTRICT COURT
FOR THE WESTERN DISTRICT OF WASHINGTON

AFFIDAVIT OF
MICHAEL F. MATTA

MARINE POWER & EQUIPMENT COMPANY

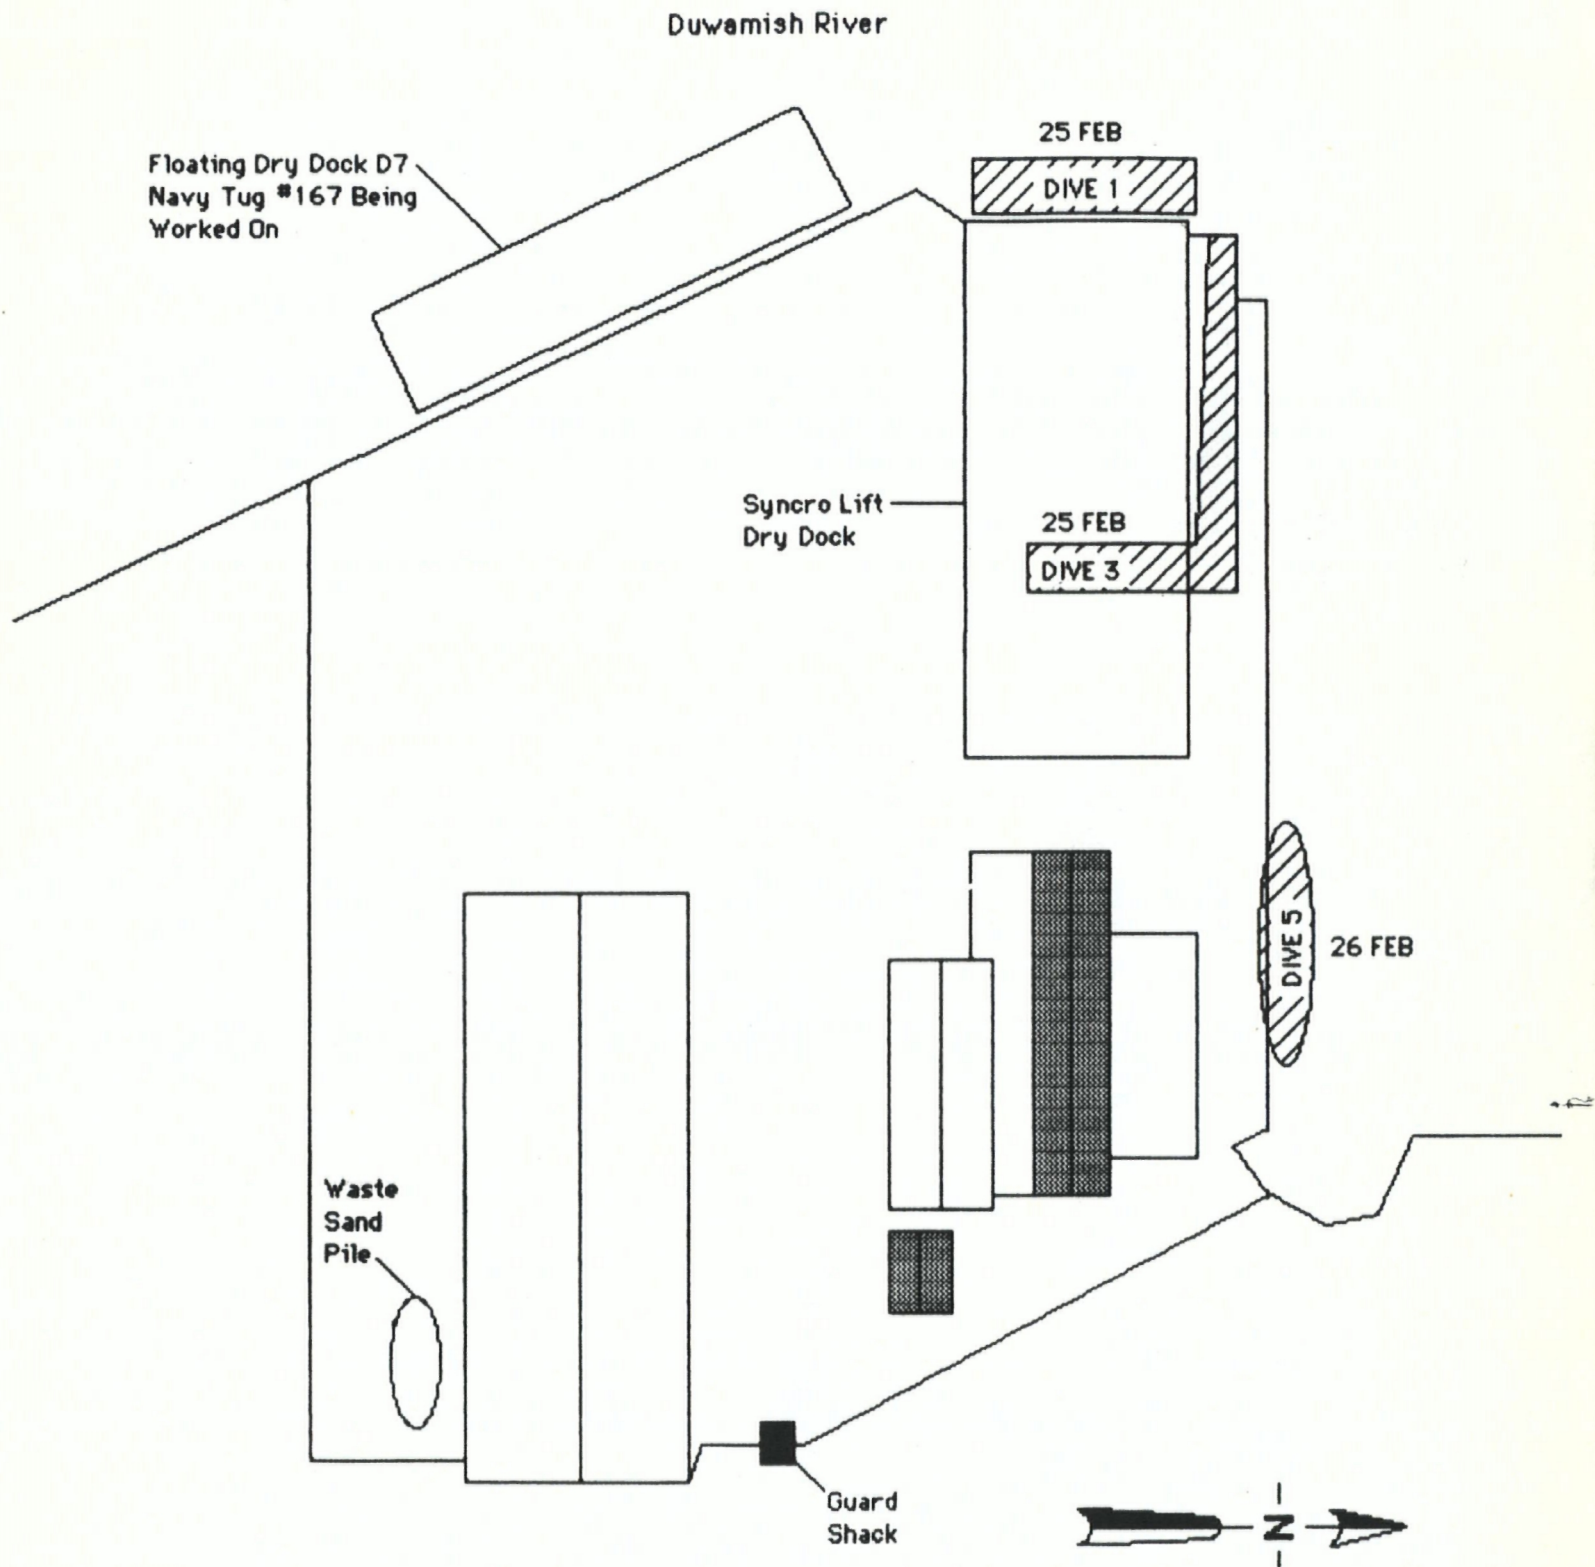
Exhibit 1 Dive Locations

7
8 3. My first dive was made between approximately 12 noon and
9 12:30 p.m. on February 25, 1985. The area that I inspected during this dive
10 is indicated in the area labeled as "Dive 1" in the diagram that is attached
11 as Exhibit 1 to this affidavit. On this dive, conducted in the vicinity of
12 the company's table dock as identified on Exhibit 1, I observed black shiny
13 granular material and paint chips covering the bottom beneath the entire edge
14 of the table dock that faces the Duwamish River. I also observed an accumu-
15 lation of material 10 feet high beneath the table dock edge. At least the
16 top one foot of this accumulation consisted of the black sandblasting grit.

17 4. I made a second dive on February 25, 1985 in the Duwamish River
18 near the Marine Power facility. This dive took place between approximately
19 3:15 p.m. and 4:00 p.m. As on my first dive that day, I was accompanied by
20 Andrew Hess, another EPA diver. During this dive I inspected the river
21 bottom in the area labeled as "Dive 3" on the diagram that is Exhibit 1
22 hereto. I observed the same black shiny material and paint chips at the
23 bottom of the river at this location as I had observed during my first dive.
24 The black sandblasting material was present in intermittent mounds underneath
25 the table dock. The mounds of black material were approximately eight inches
26 in height.

1 5. On February 26, 1985, I made another dive in the same general
2 area of the Duwamish River near the facilities of Marine Power and Equipment
3 Company. This dive took place between approximately 12:30 p.m. and 1:00 p.m.
4 The area of the river bottom that I inspected during this dive is indicated
5 by the area labeled as "Dive 5" on Exhibit 1. Near the pier pilings, at a
6 depth of approximately 30 feet, I observed deposits of black sandblasting
7 material and paint chips. I probed the sediment with my hand and determined
8 that the sandblasting material had accumulated to a depth of at least ten
9 inches near the base of the pier.

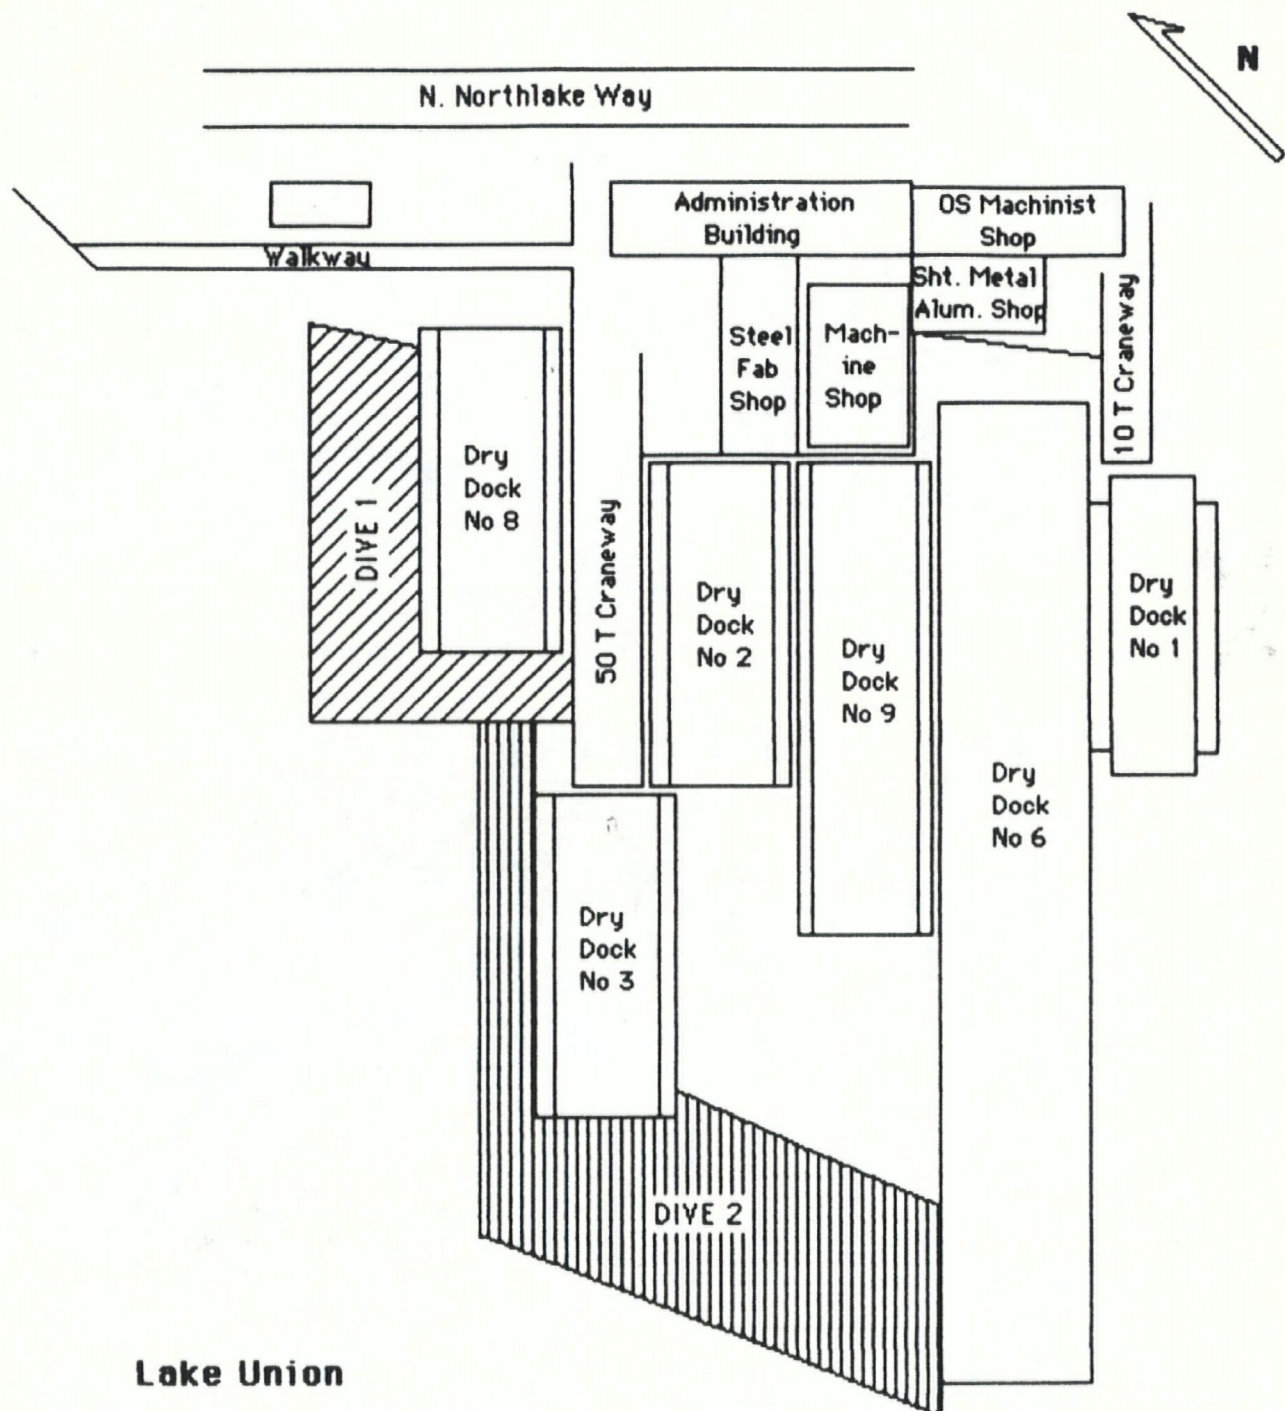
Exhibit 2 Dive Locations

19
20 9. On February 27, 1985, I made two dives near the Marine Power and
21 Equipment facility located on Lake Union at 1441 North Northlake Way, Seattle,
22 Washington. A layout of the company's Lake Union dry dock facility is given
23 on the diagram that is attached as Exhibit 2 hereto. That diagram shows the
24 locations of dry docks numbered 1-3 and 6, 8 and 9, and also shows the areas
25 that I inspected during Dive 1 and Dive 2. My first dive took place between
26

1 approximately 10:30 a.m. and 11:00 a.m. During that dive I inspected the area
2 identified as "Dive 1" on Exhibit 2. On that dive, I observed sandblasting
3 debris, including paint chips, on the bottom of the lake on the southern and
4 western sides of dry dock No. 8. These deposits extended to a depth of at
5 least one foot and also contained numerous colored paint chips. I also
6 observed a white paint spill on the bottom of the lake south of dry dock No. 8
7 adjacent to the craneway at the dock. The paint stuck to my swim fins and
8 gloves.

9
10 10. My second dive on February 27, 1985 at the Lake Union facility
11 of Marine Power was made between 12:37 p.m. and 1:10 p.m. The area that I
12 inspected during this dive is identified as "Dive 2" on the diagram that is
13 Exhibit 2. During this dive I observed deposits of sandblasting material
14 between the southern ends of dry docks Nos. 3 and 6. This material had been
15 deposited in crust-like layers on the lake bed, in depths of at least one
16 foot. Water depth in the area was forty feet. By comparison, the water
17 depth in the adjacent Lake Union ship channel is 50 feet and contains sedi-
18 ments that are very light in color and weight, and consist of very fine
19 particles.
